CITY OF LODI

COUNCIL COMMUNICATION

AGENDA TITLE: Direct staff to: 1) pursue long-term lease agreements for the City Hall Annex and retail/office space in the Lodi Station Parking Structure; and 2) continue with plans to remodel the old Public Safety Building and City Hall to accommodate the relocation of certain departments

Civic Center Space Planning

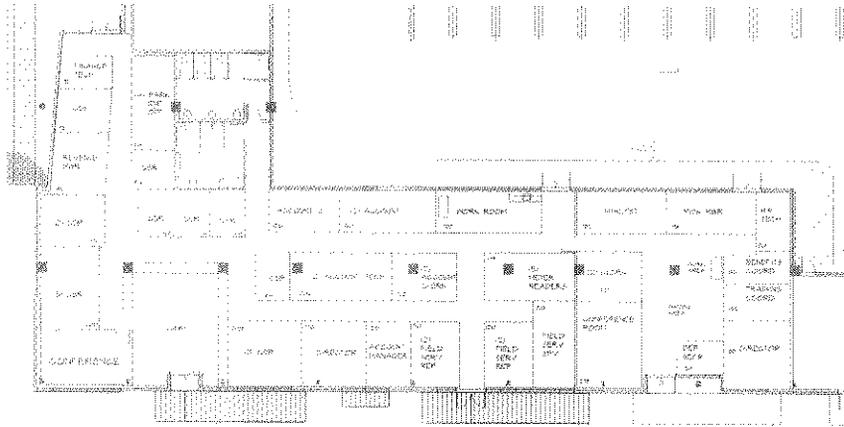
Scenario Details - 1) Fin. & HR to Parking Structure, ... (cont'd)

- Saks Bldg. – currently leased for PCE/TCE Public Document archive. Lease would need to be extended.
- Small portion planned for some City staff.
- Unused storage space could be converted for IS with some additional walls, electrical & data line work.
- Costs include:
 - \$75,000 for tenant improvements
 - \$36,000 for lease (assumed 18 months)

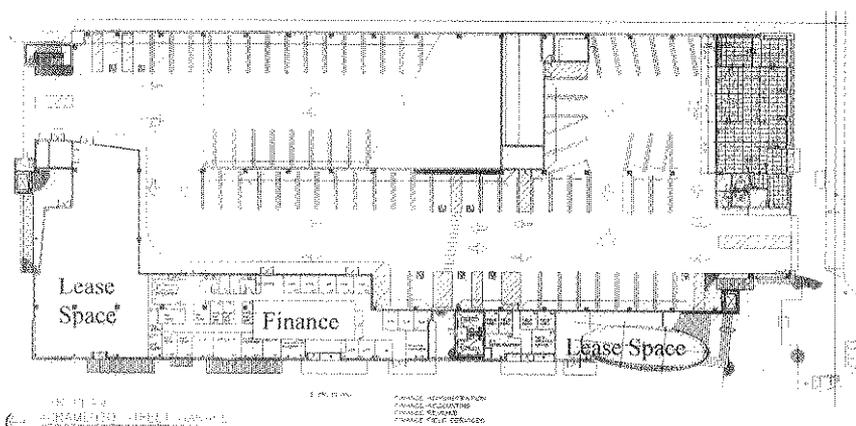
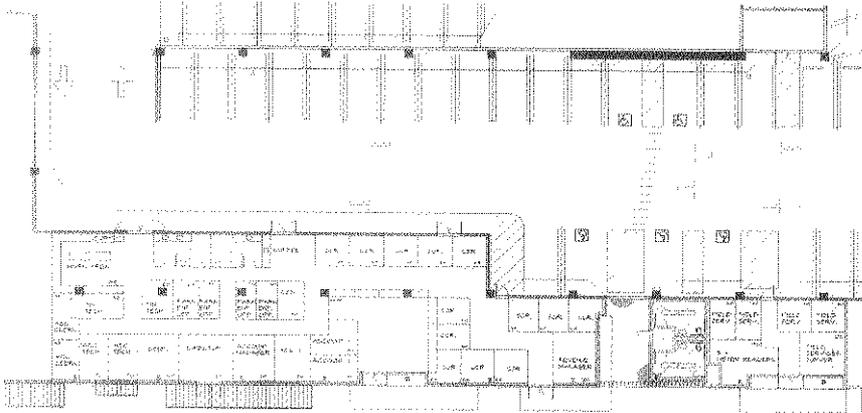
Scenario Details - 2) Finance to Parking Structure... (cont'd).

- ❑ Leaves major restaurant space at north end available
- ❑ Helps solve Civic Center parking and loss of Annex parking lot on Oak.
- ❑ Costs include:
 - \$324,000 for tenant improvements
 - Slightly over half reusable by future developer
 - Mobile office costs approx. \$130,000
 - Assumed located in grass next to parking lot north of Carnegie Forum away from Vet's Fountain
 - Saks same as Scenario 1)

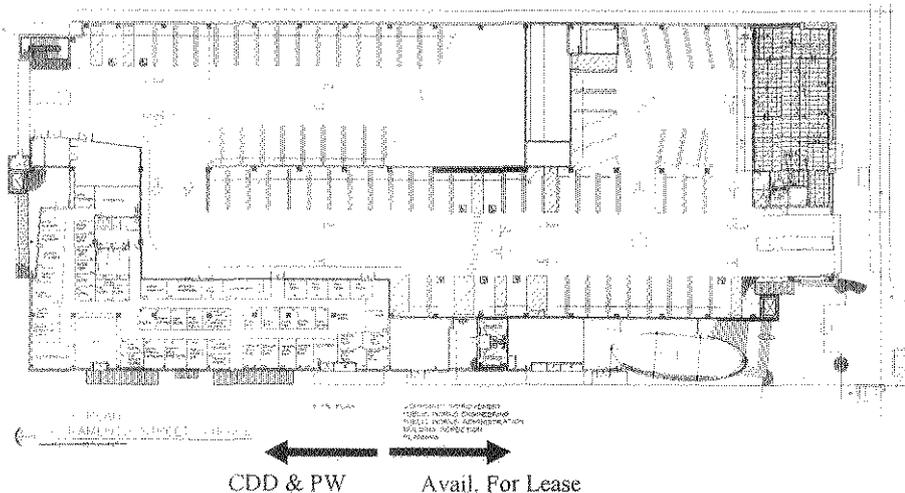
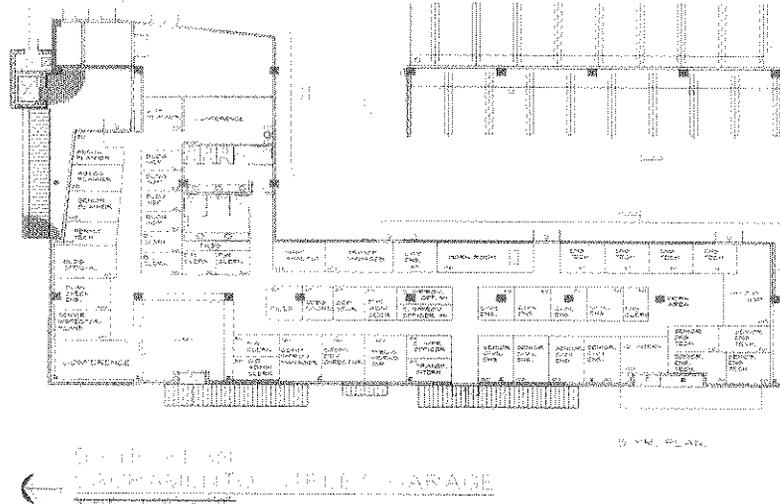
Scenario Details - 3) CDD & PW to Parking Structure....(cont'd)

- CDD & PW would need 8,000 SF at north end (leaves 2,725 SF for lease).
- Helps solve Civic Center parking and loss of Annex parking lot on Oak.
- Costs include:
 - \$467,000 for tenant improvements
 - Slightly over half reusable by future developer
 - Some work in City Hall, compatible with long-term plan
 - Saks same as Scenario 1)

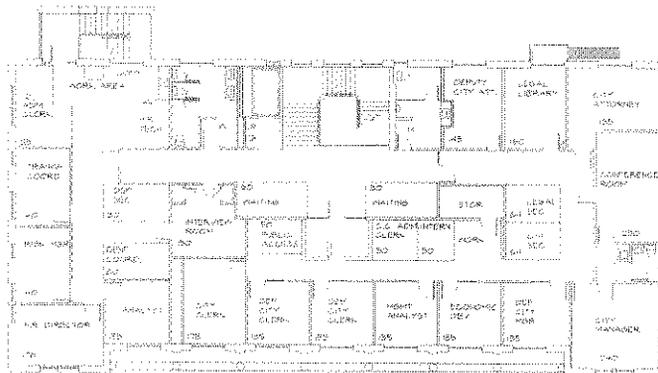
Scenario Details - 3) ...City Hall Modifications for HR expansion.

11.000.000 - FLOOR PLAN
FLOOR PLAN
CITY MANAGER
CITY ATTORNEY
CITY CLERK
HR
ECONOMIC DEV.
CITY MANAGER
