CITY COUNCIL MEETING
SEPTEMBER 2, 1987

PARKING STUDY AND
NEEDED CURB AND
GUTTER IMPROVEMENTS
AT BUS DEPOT ON PINE
STREET EAST OF
STOCKTON STREET
REVIEWED

PINE & STOCKTON BUS DEPOT PARKING LAYOUT

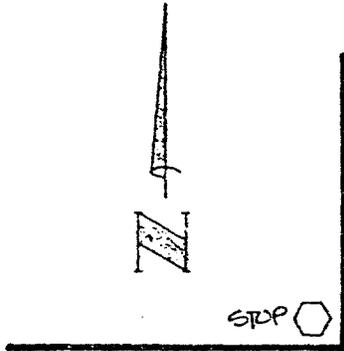
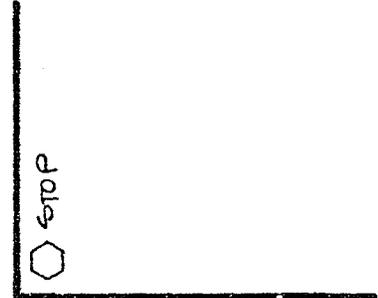
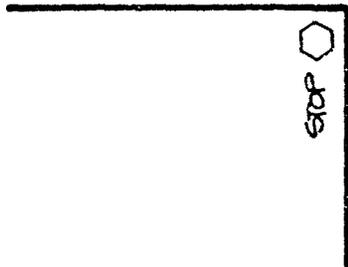
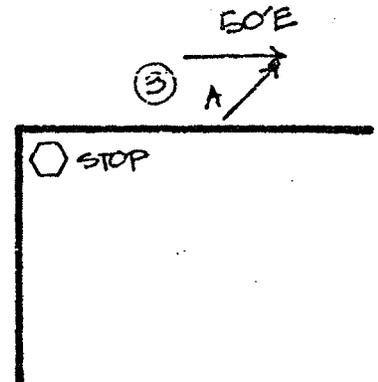
STOCKTON and FINE

Nov. 3, 1986 - Aug 12, 1987

No.	DATE	TIME	DAMAGE	INJURED	APPARENT CAUSE (A)
1	11-3-86	1155	MIN-MIN	1	UNSAFE SPEED N/E
2	1-8-87	1207	MIN-MIN	0	TRUCK IN YIELD
3	7-30-87	1307	MOD-MOD	0	UNSAFE OVERTAKING

- PATH OF MOVING VEHICLE
- REAR END COLLISION
- FIXED OBJECT
- PARKED VEHICLE
- SIDESWIPE

1. Buses Blocking the Stop Sign - We have received various complaints and witnessed buses blocking the view of the stop sign. Staff reviewed the accidents after the bus zone installation. There have been three accidents and none of them were caused by the bus blocking the stop sign (see Exhibit A). The majority of the complainants witnessed vehicles running the stop sign when a bus was unloading/loading passengers and blocking the sign.
